# **Selected Images of the Effects of the October 15, 2006, Kīholo Bay-Māhukona, Hawai‘i, Earthquakes and Recovery Efforts**

Data Series 506

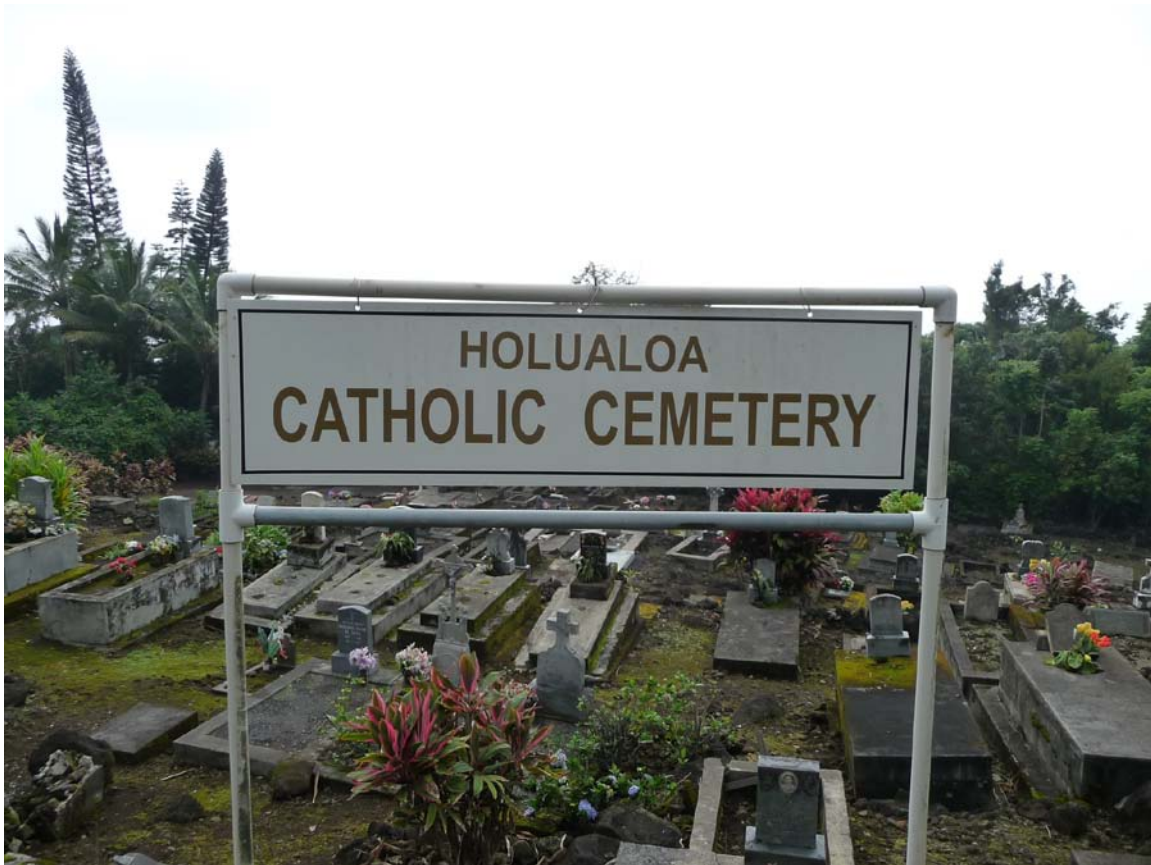
34.8. *Overview image:* New sign and view of the partially restored Hōlualoa Catholic Cemetery. Many of the headstones and sunken bases were filled and reset, but fragments of some structures remain untouched (view to the west-southwest). USGS photo by N.A. Ikeda, 7/27/2008 (nai1045).

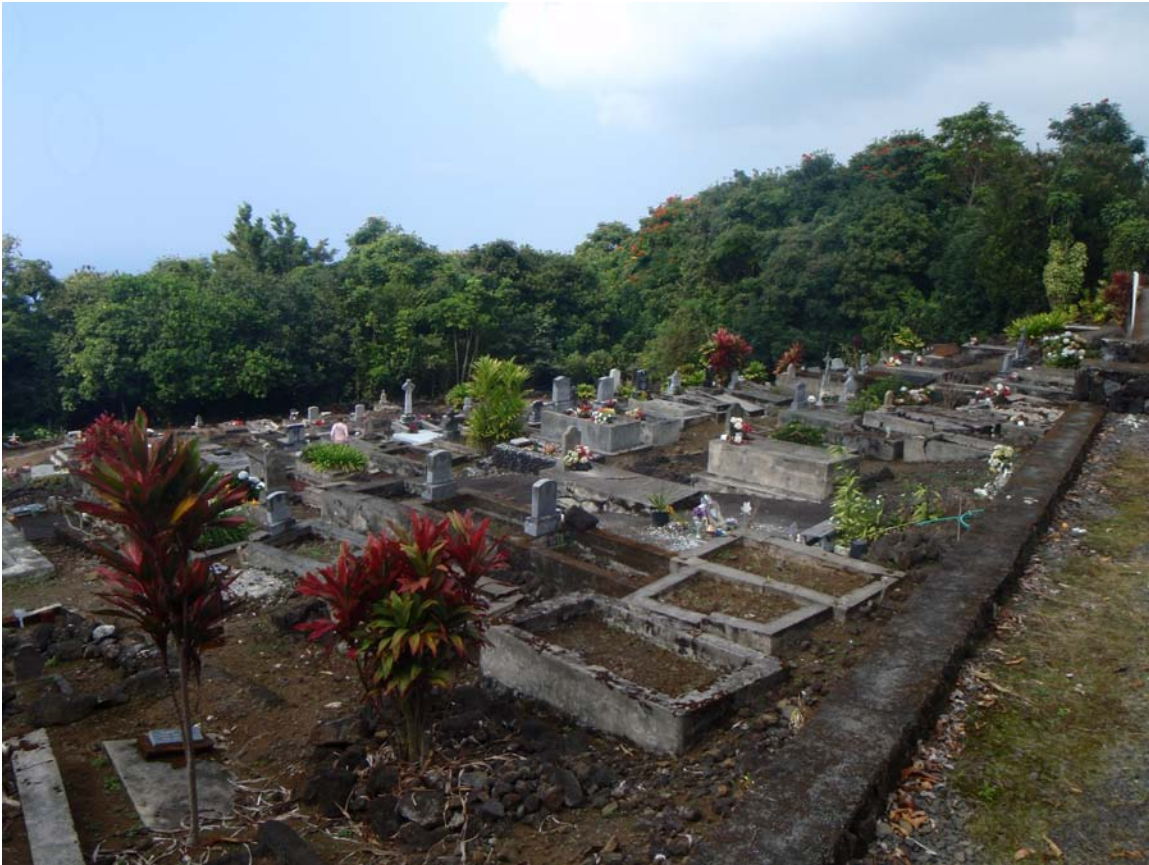
34.9. *Overview image*: The friable nature of the ground and the closely spaced plots present a quandary in the restoration of the cemetery (view to the northwest). USGS photo by N. Steiner and T. Steensen, 1/24/2009 (nas-tss192).

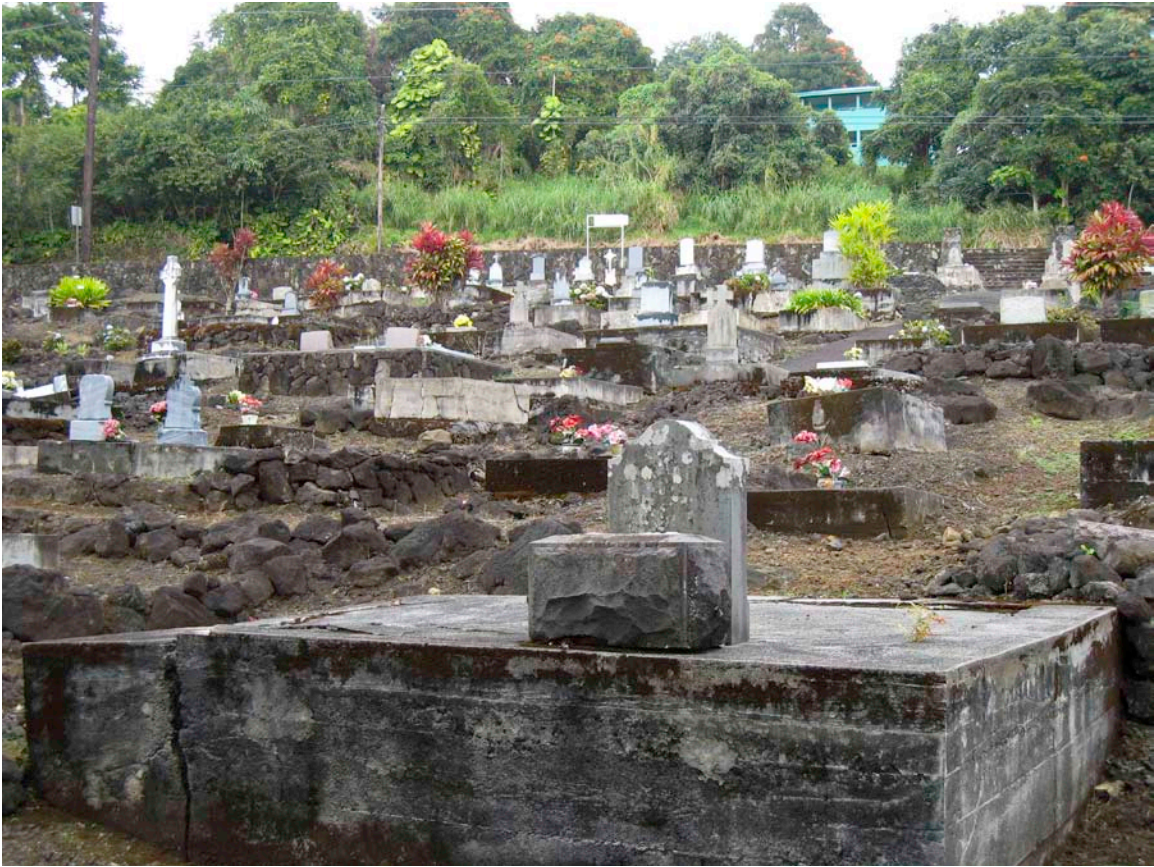
34.10. *Overview image:* The degree of slope contributed to ground slumping and the fracturing of headstones (view to the northeast). USGS photo by T.J. Takahashi, 2/7/2009 (tjt1163).

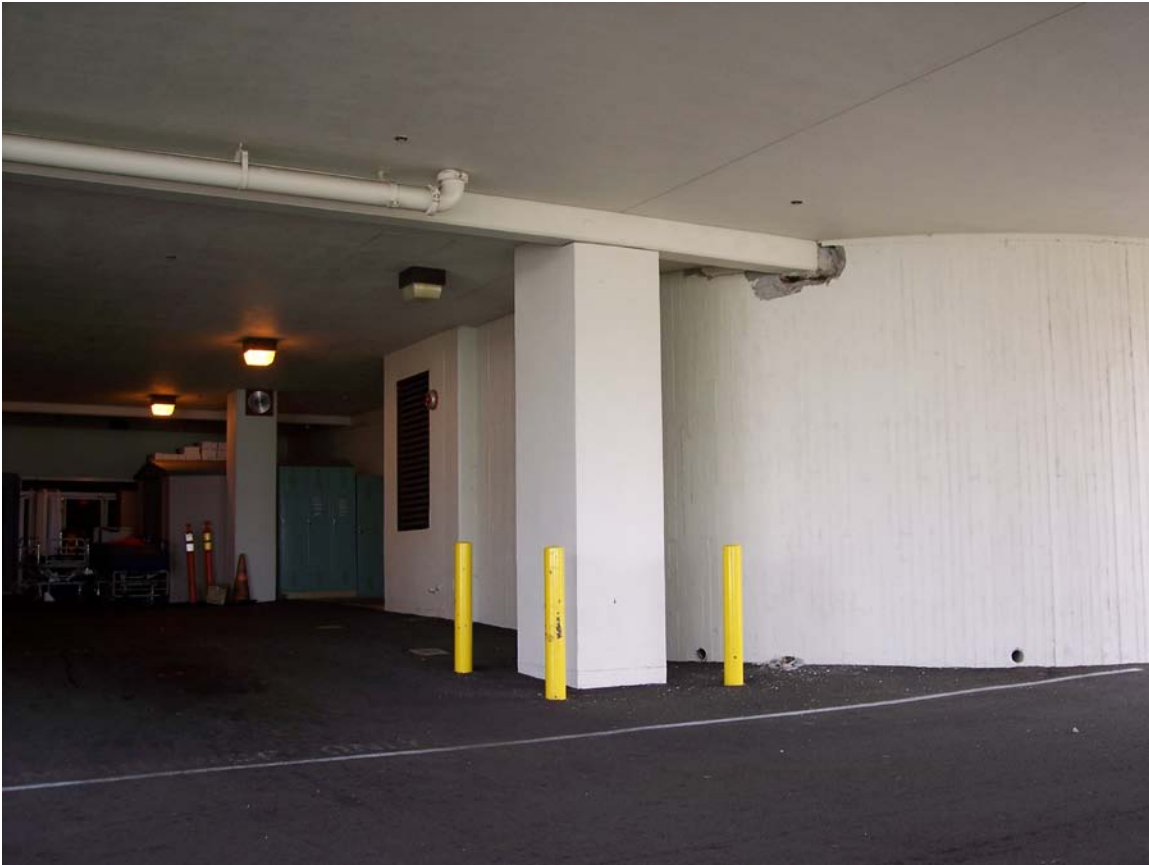
35.5. View of damage to the wall, intersected by a post beam, on the ground floor of the hospital wing in the ambulance port (view to the east). USGS photo by T.J. Takahashi, 10/28/2006 (tjt1616).

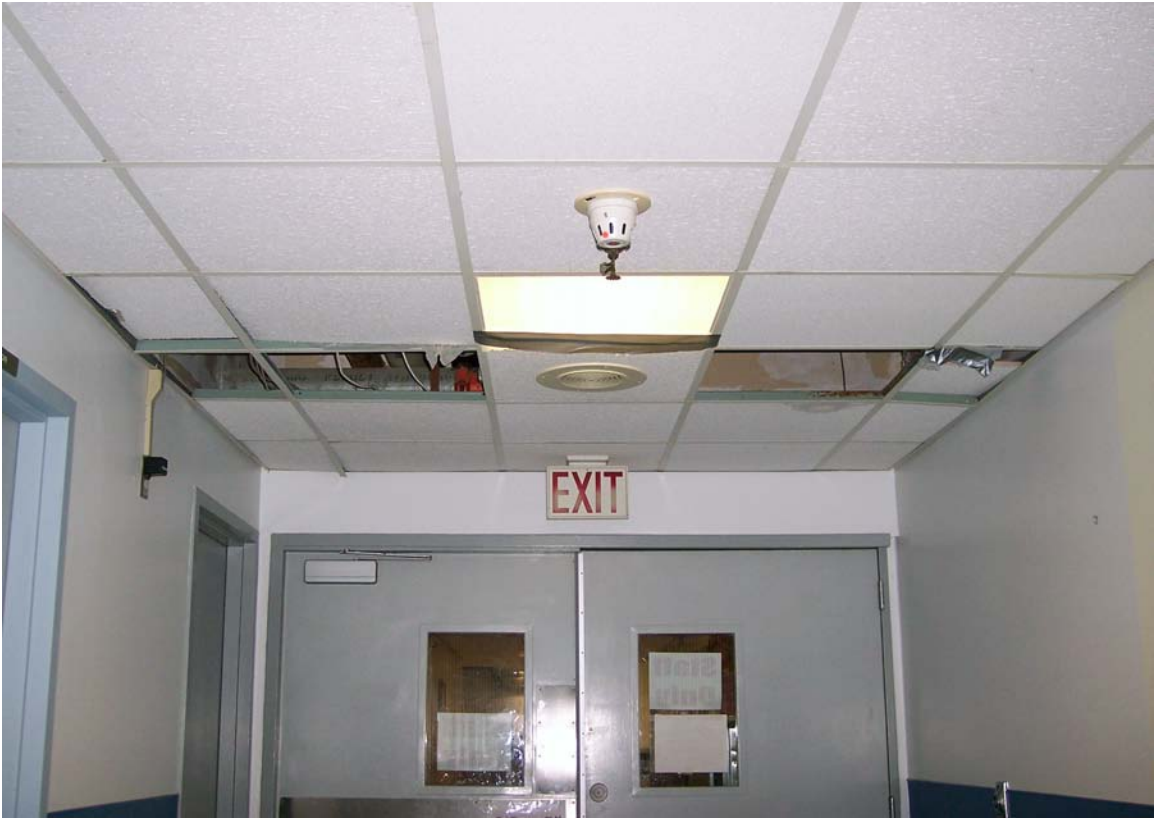
Kona Community Hospital, located in Kealakekua, Kona, is a 94-bed primary-care facility, housed in a three-story structure, serving the people of West Hawai‘i. When the earthquake occurred, dust from ceiling tiles—which fell when the T-bars in the ceiling buckled—caused widespread air contamination throughout the hospital. Structural damage, except for the post beam, consisted of hairline cracks in the walls. Some ground cracks also appeared. Patients were quickly evacuated to the nearby Sheraton Hotel and a temporary “tented” hospital put in place on the hospital’s grounds. A generator and a backup borrowed from the County of Hawaii provided temporary power, and portable luas (toilets) were placed near the hospital tents. Within two weeks after the earthquake, the primary-care hospital was operational again. Its rapid recovery is attributed to extensive support from the community, from local workers, and from volunteers. As part of its hazards mitigation strategy, large pieces of equipment, such as generators and gas tanks, were bolted to the concrete pavement on which they stood in order to prevent movement during future earthquakes (Eaton, 2006).

35.6. View of damage to suspended ceiling panels, light fixtures, and ventilation (view to the south). USGS photo by T.J. Takahashi, 10/28/2006 (tjt1647).

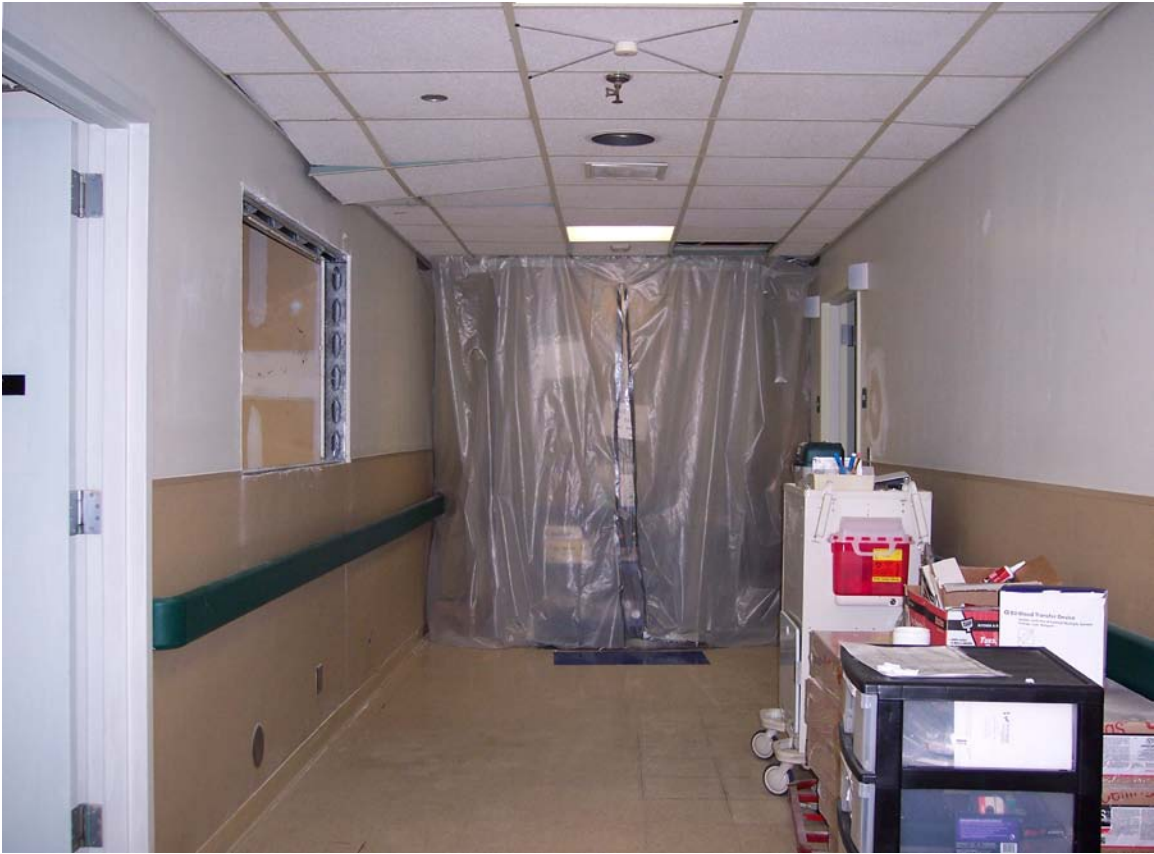
35.7. View of plastic sheeting used to protect obstetrics ward from dust contamination. Note damage to suspended ceiling (view to the south). USGS photo by T.J. Takahashi, 10/28/2006 (tjt1651).

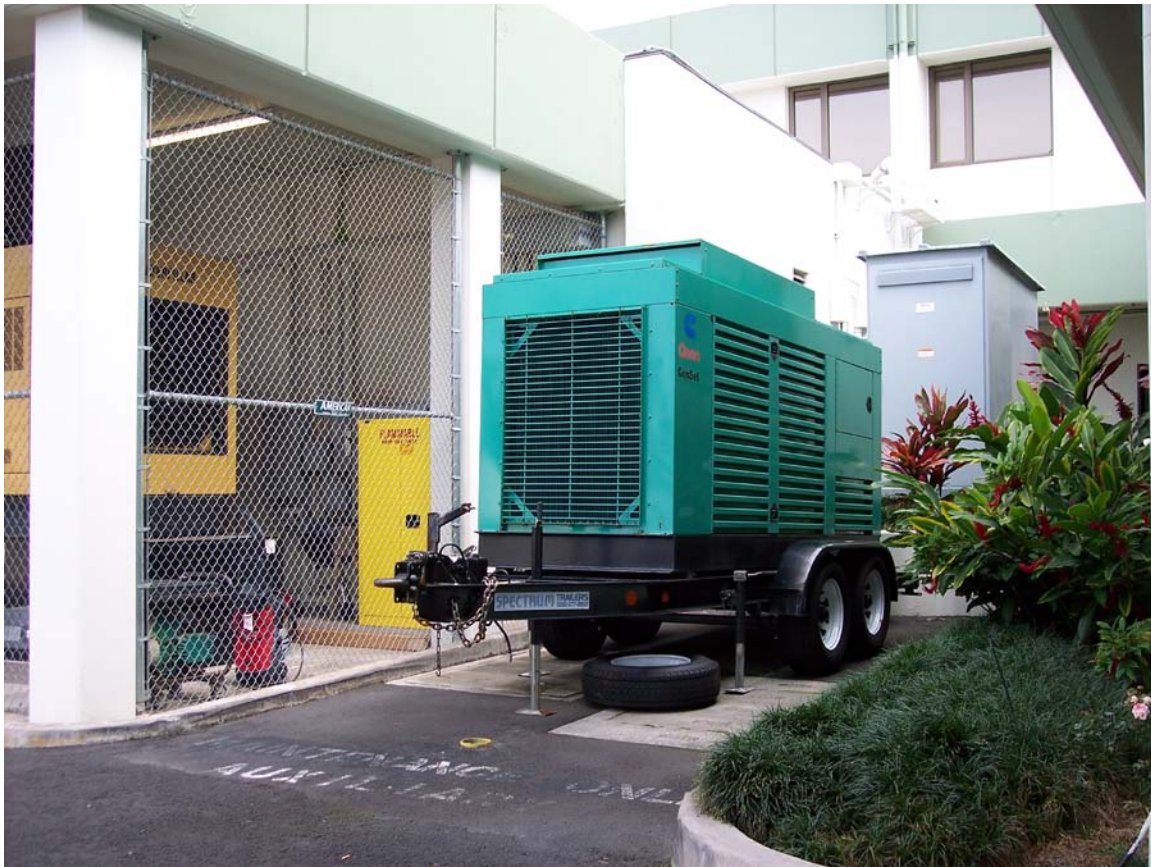
35.13. View of the backup generator, borrowed from the County of Hawaii, to supply electrical power during outages until the hospital became fully operational again (view to the north-northwest). USGS photo by T.J. Takahashi, 10/28/2006 (tjt1633).

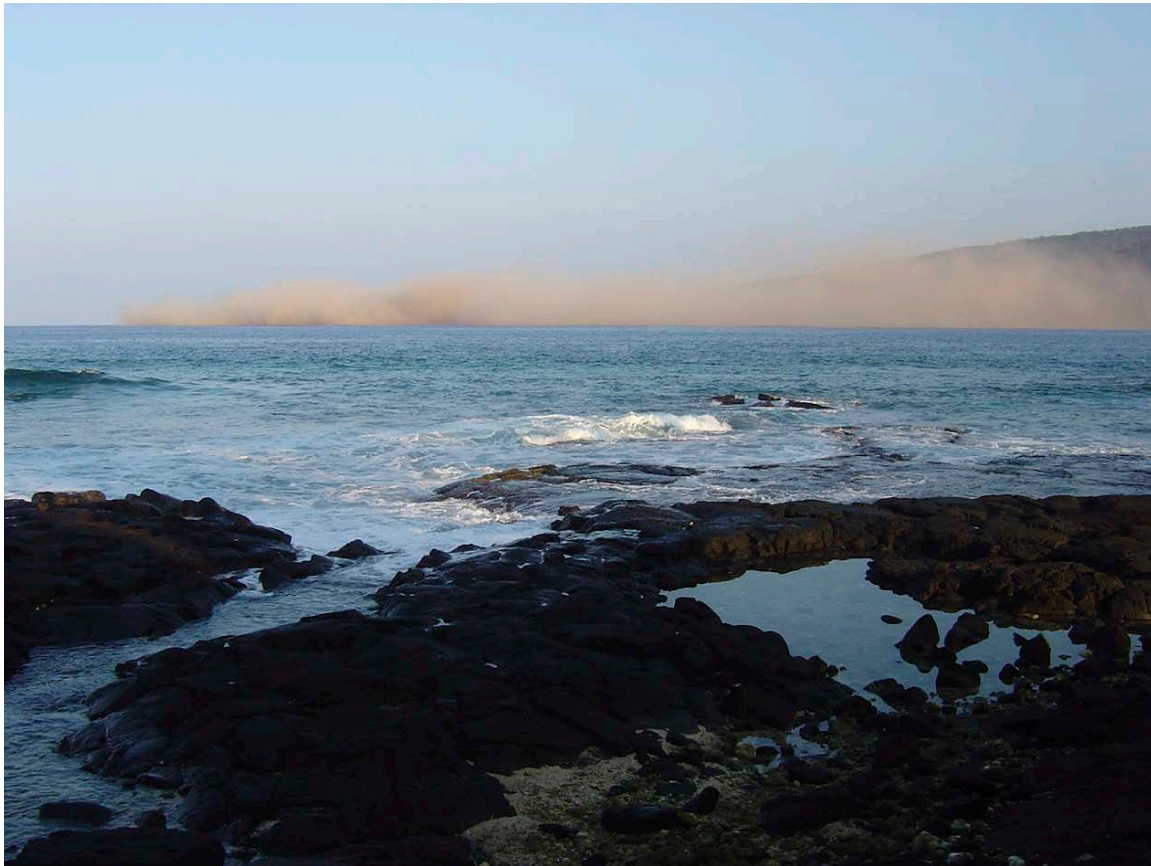
36.1. View of the dust cloud that blew across the ocean and obscured the Ka‘awaloa lava delta of Kealakekua Bay from view (view to the north-northwest from Ke‘ei shoreline). Photo by J.P. Lockwood, 10/15/2006 (jpl001).

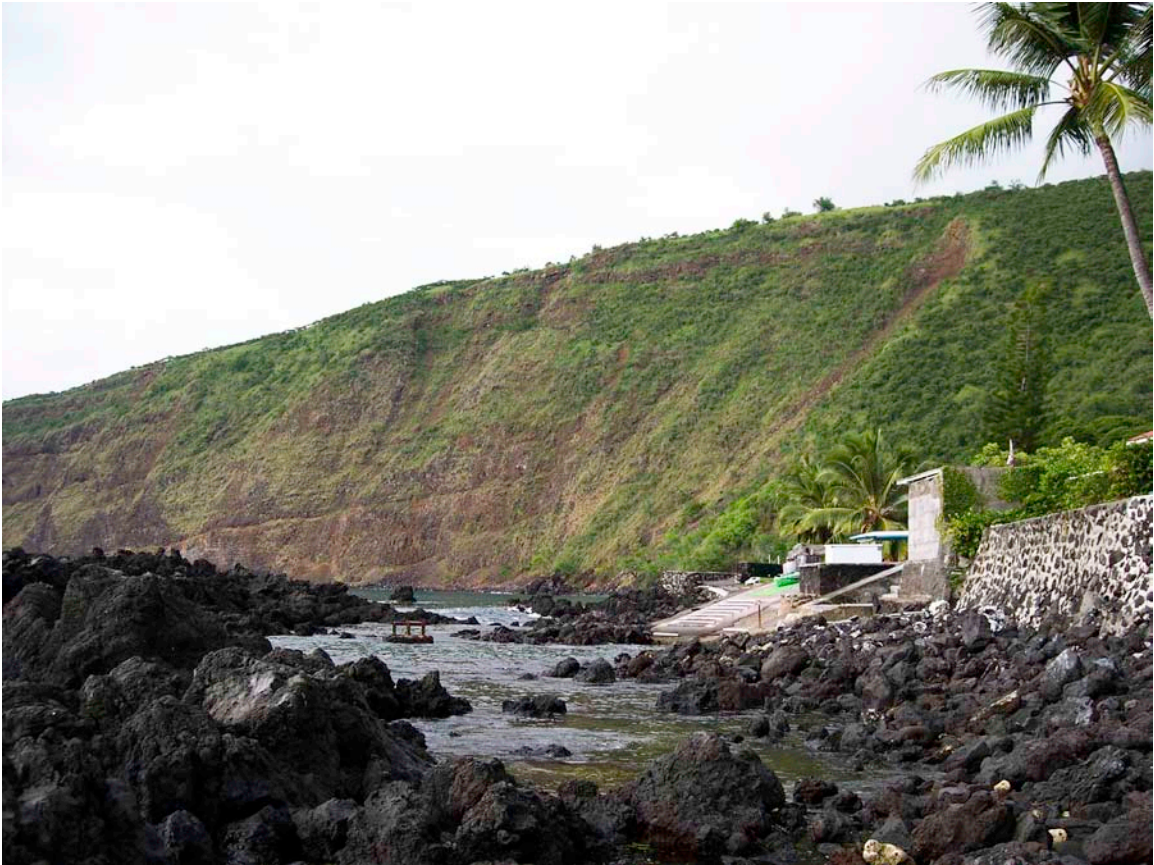
36.2. View of scarring by rock slides at the southeastern end of the fault, across the mid-section of the sea cliff along Kealakekua Bay (view to the northwest from the Napo‘opo‘o shoreline). USGS photo by T.J. Takahashi, 11/8/2006 (tjt1966).

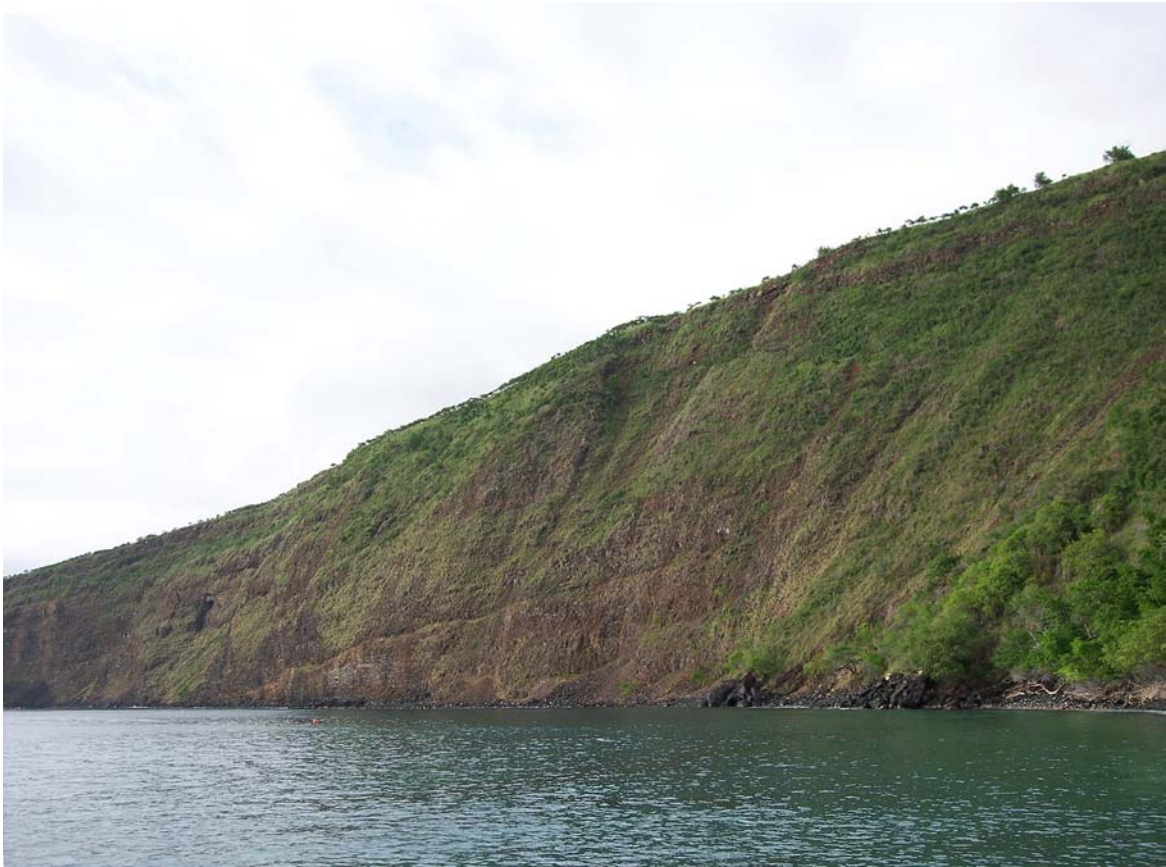
36.3. Close-up view of scarring on the sea cliff at Napo'opo'o, toward the west-northwest end of the bay from the rock falls. Note talus from rock falls at the base of the cliff (view to the northwest from the Napo'opo'o shoreline). USGS photo by T.J. Takahashi, 11/8/2006 (tjt1983).

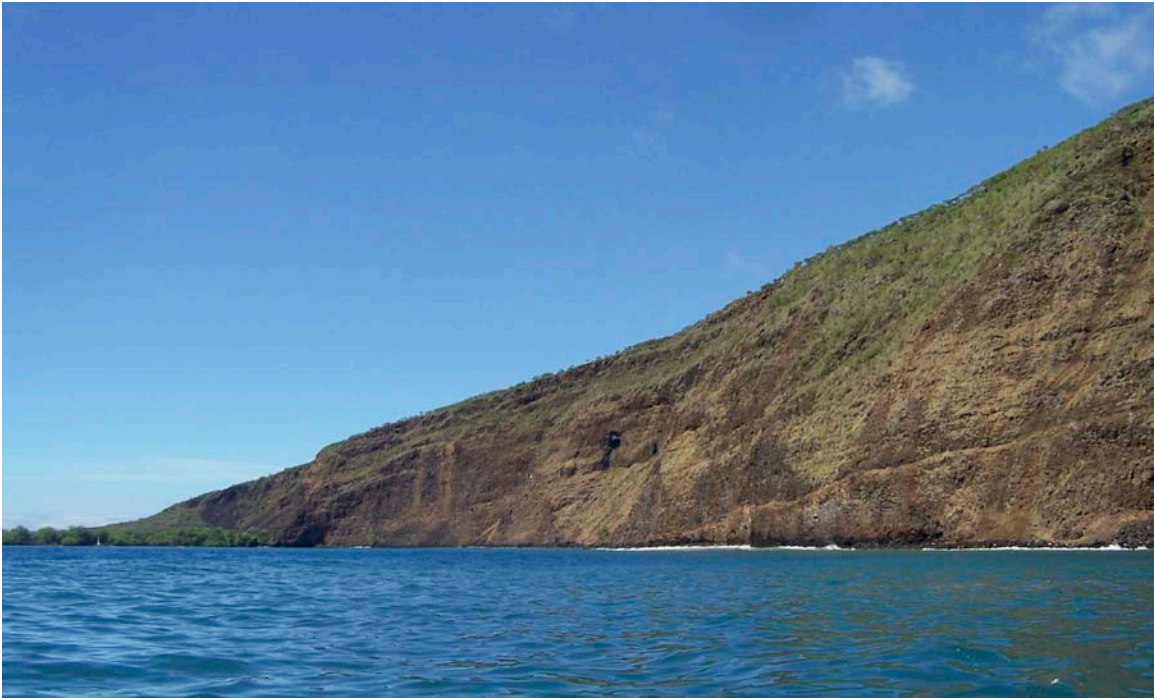
36.4. Wide-angle view of Kealakekua Bay, from the boat at the Napo‘opo‘o end of the bay—showing fresh scarring on the sea cliff about halfway across the bay—to the Ka‘awaloa lava delta (view to the west-northwest). DLNR photo by K. Gooding, 10/19/2006 (kg1374).

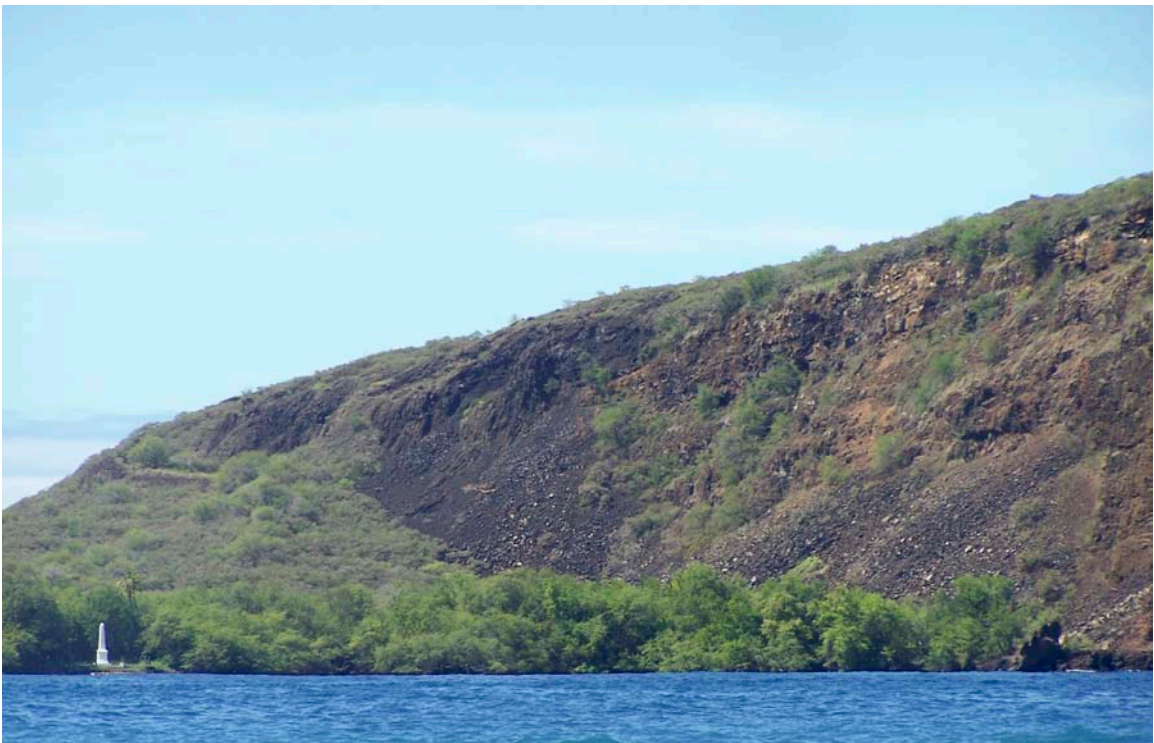
36.5. Extensive series of rock falls above the Ka‘awaloa lava delta, viewed from the boat in Kealakekua Bay. Note Captain Cook Monument (lower left of photo) at the cliff’s base (view to the northwest). DLNR photo by K. Gooding, 10/19/2006 (kg1378).

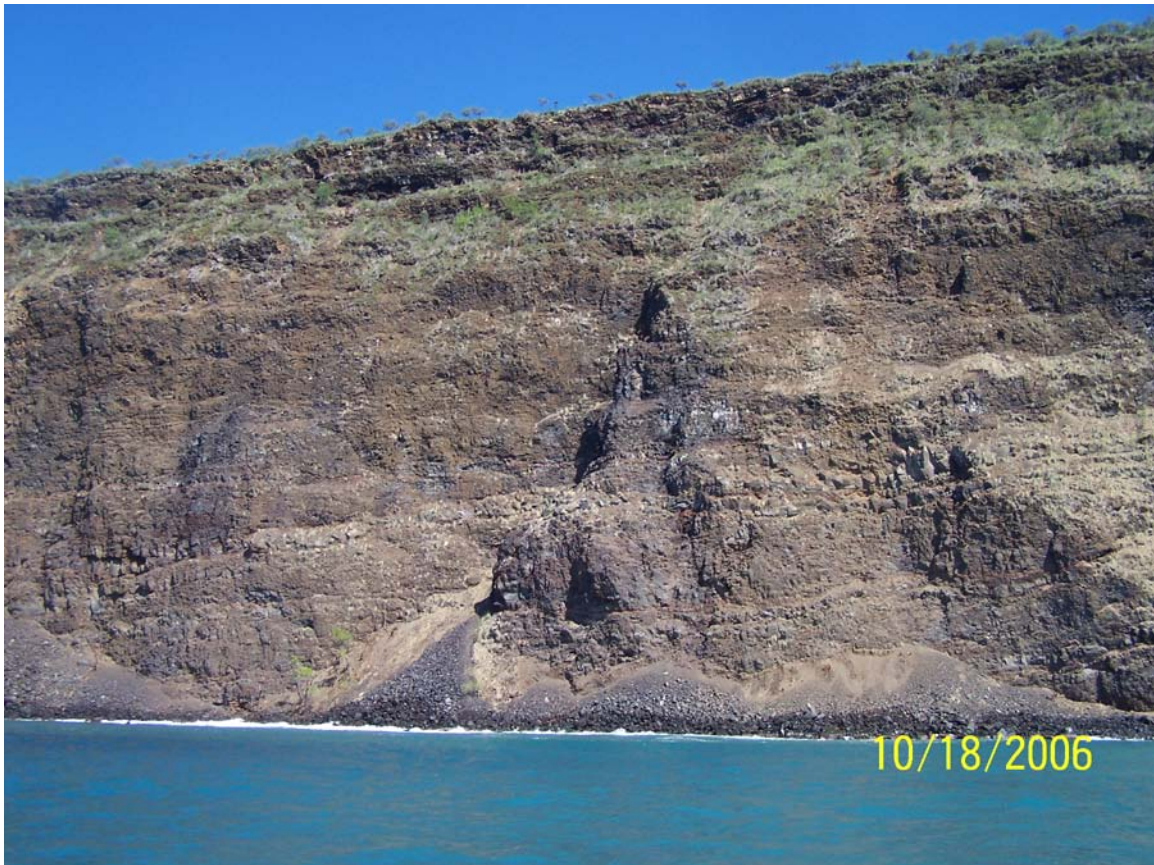
36.6. Detail of rock-fall damage across the sea cliff and talus deposits toward the end of the fault at the Ka‘awaloa lava delta. The Captain Cook Monument stands at the base of the cliff (view to the north-northwest from the boat). DLNR photo by K. Gooding, 10/19/2006 (kg1303).

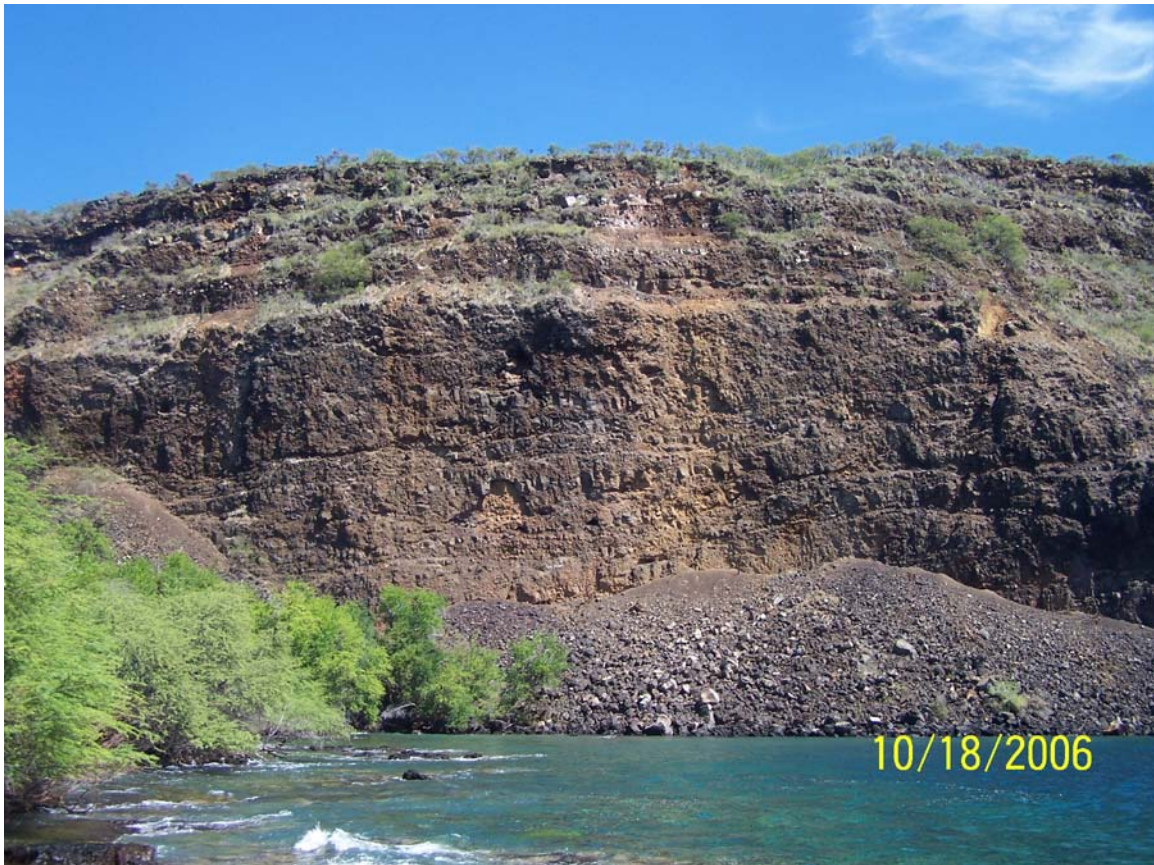
36.7. Detail of the light orange-brown scar on the sea cliff and rock-fall deposits on the shoreline of the Ka'awaloa lava delta, north-northeast of the Captain Cook Monument (view to the northeast). DLNR photo by K. Gooding, 10/19/2006 (kg1308).

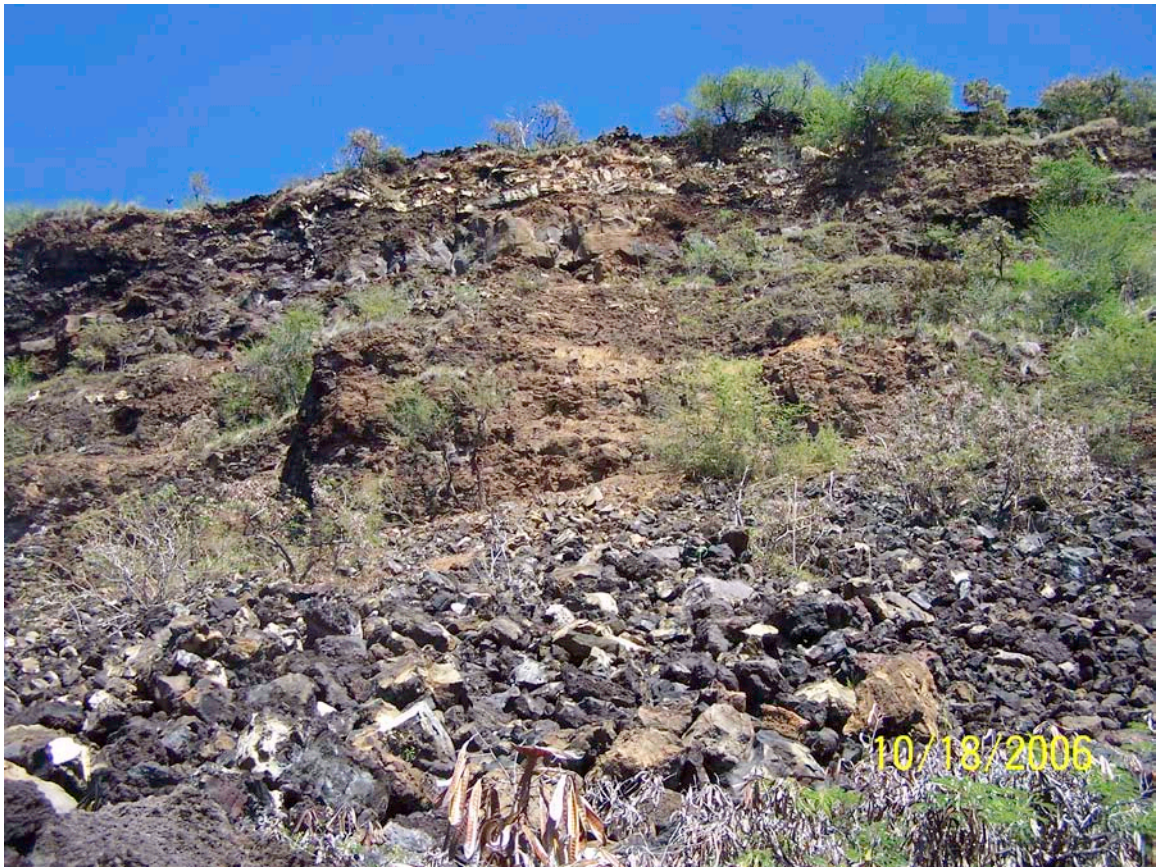
36.8. Detail of the light-brown scar on the sea cliff and rock-fall deposits above the Kaʻawaloa lava delta, north-northeast of the Captain Cook Monument (view to the north-northeast). DLNR photo by K. Gooding, 10/19/2006 (kg1334).

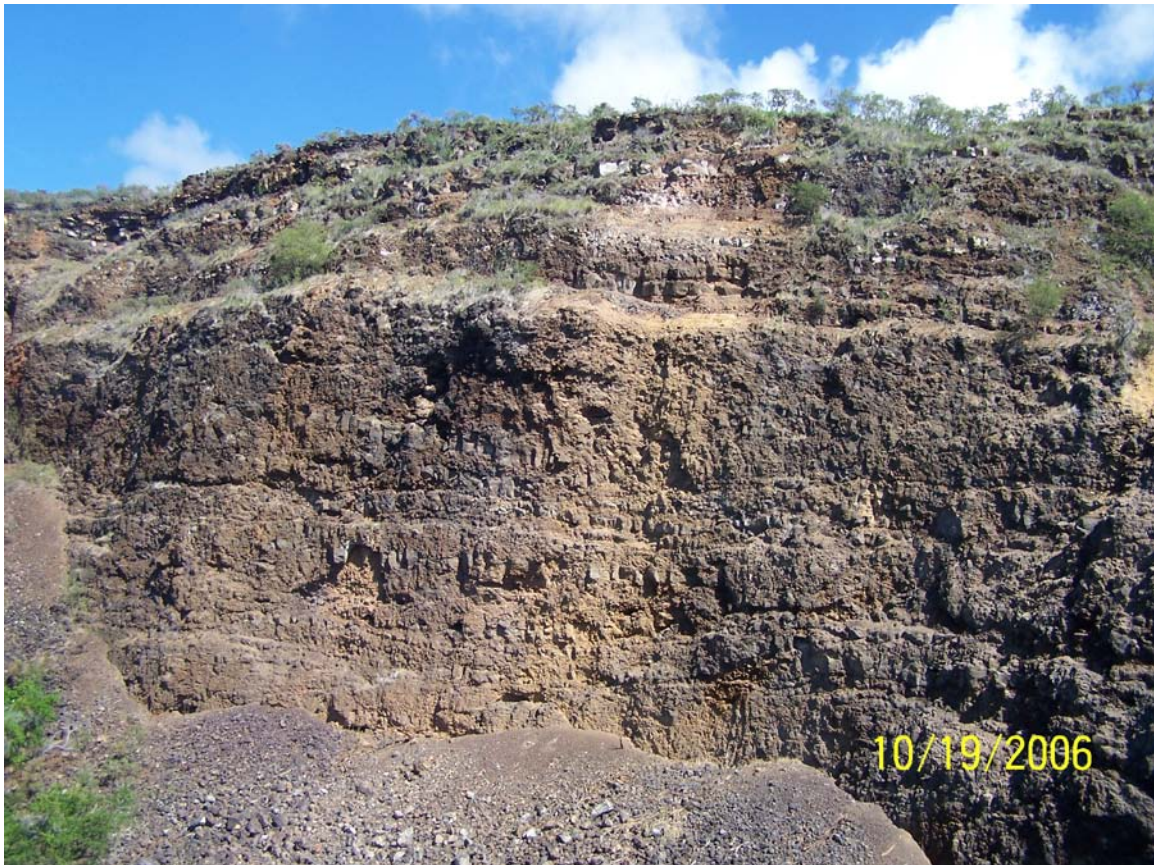
36.9. Detail of rock-fall deposits and scarring of the entire section (from top to bottom) of the sea cliff and the adjoining Ka'awaloa lava delta north-northeast of the Captain Cook Monument (view to the north). DLNR photo K. Gooding, 10/19/2006 (kg1510).

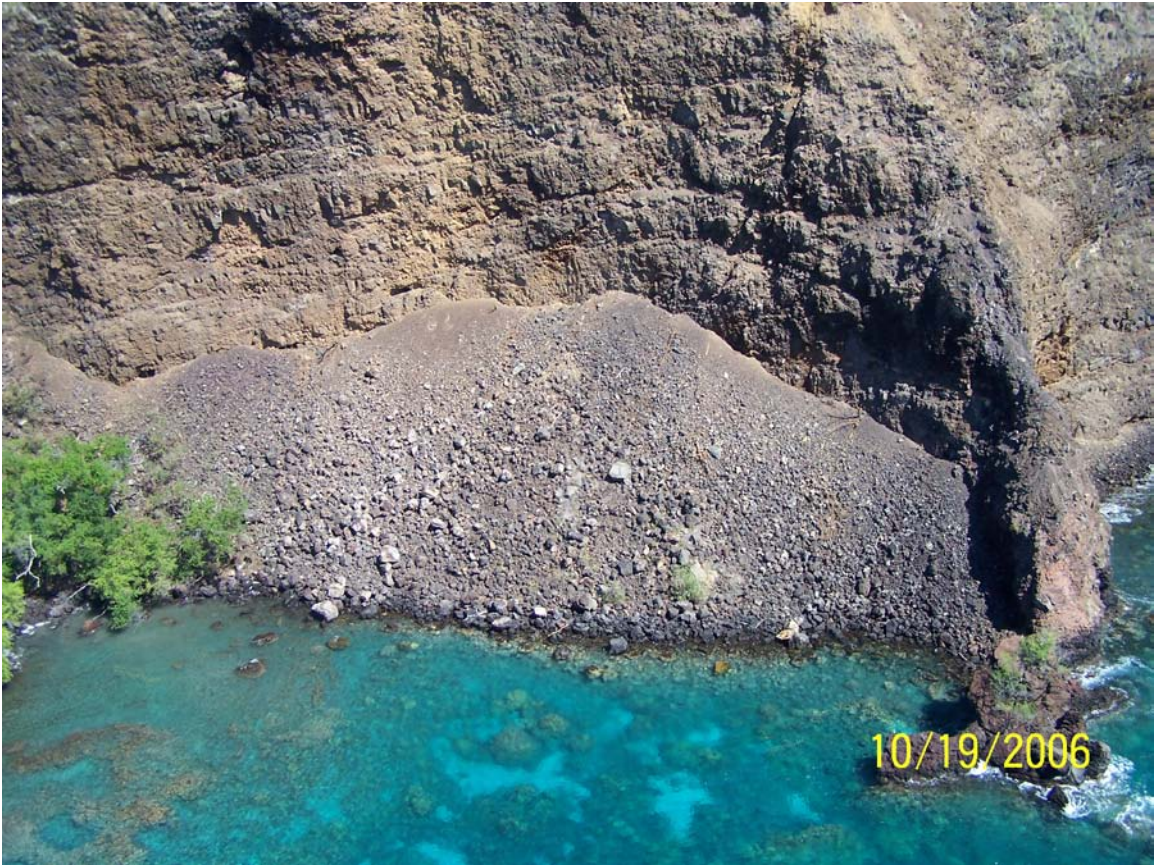
36.10. Close-up aerial view of the scarred sea cliff and rock-fall deposits adjoining the Kaʻawaloa lava delta north-northeast of the Captain Cook Monument (view to the north). DLNR photo by K. Gooding, 10/19/2006 (kg1513).

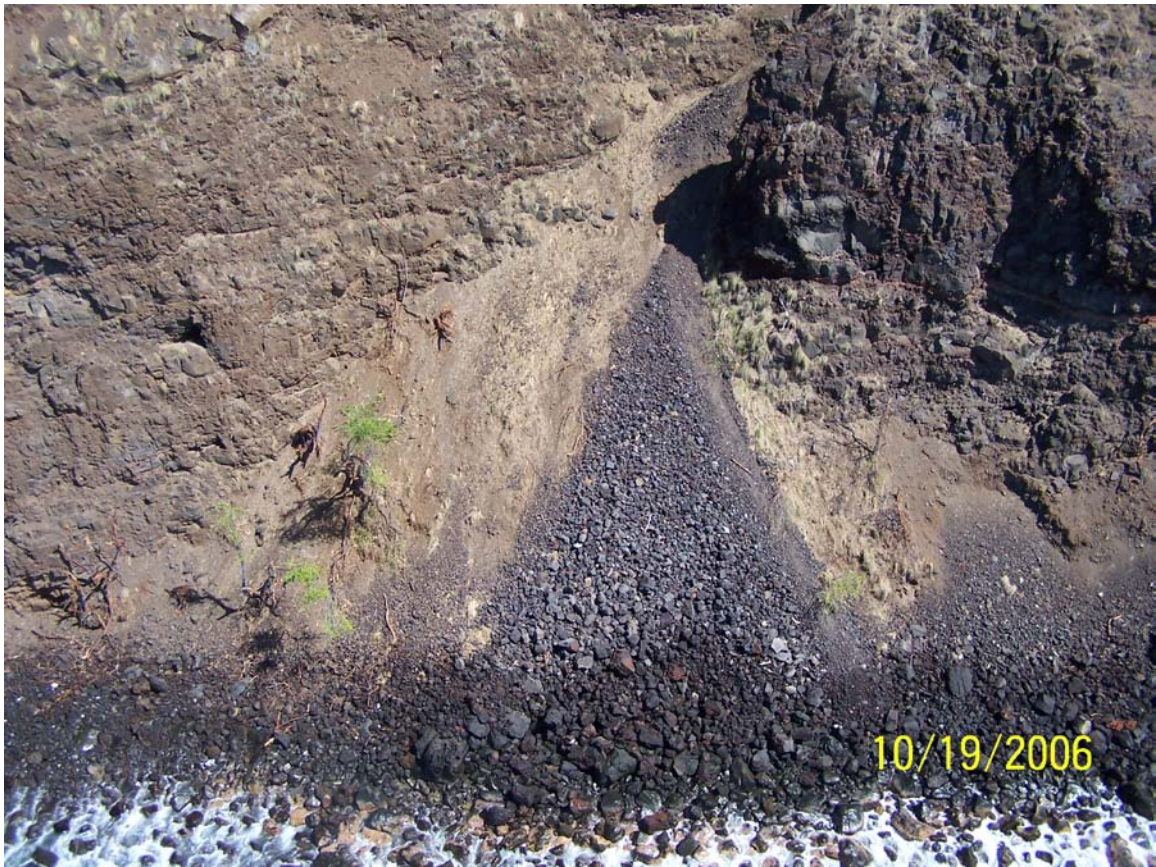
36.11. Close-up aerial view of the sea cliff and talus deposit approximately two-thirds of the way across the Kealakekua fault (view to the northeast). DLNR photo by K. Gooding, 10/19/2006 (kg1518).

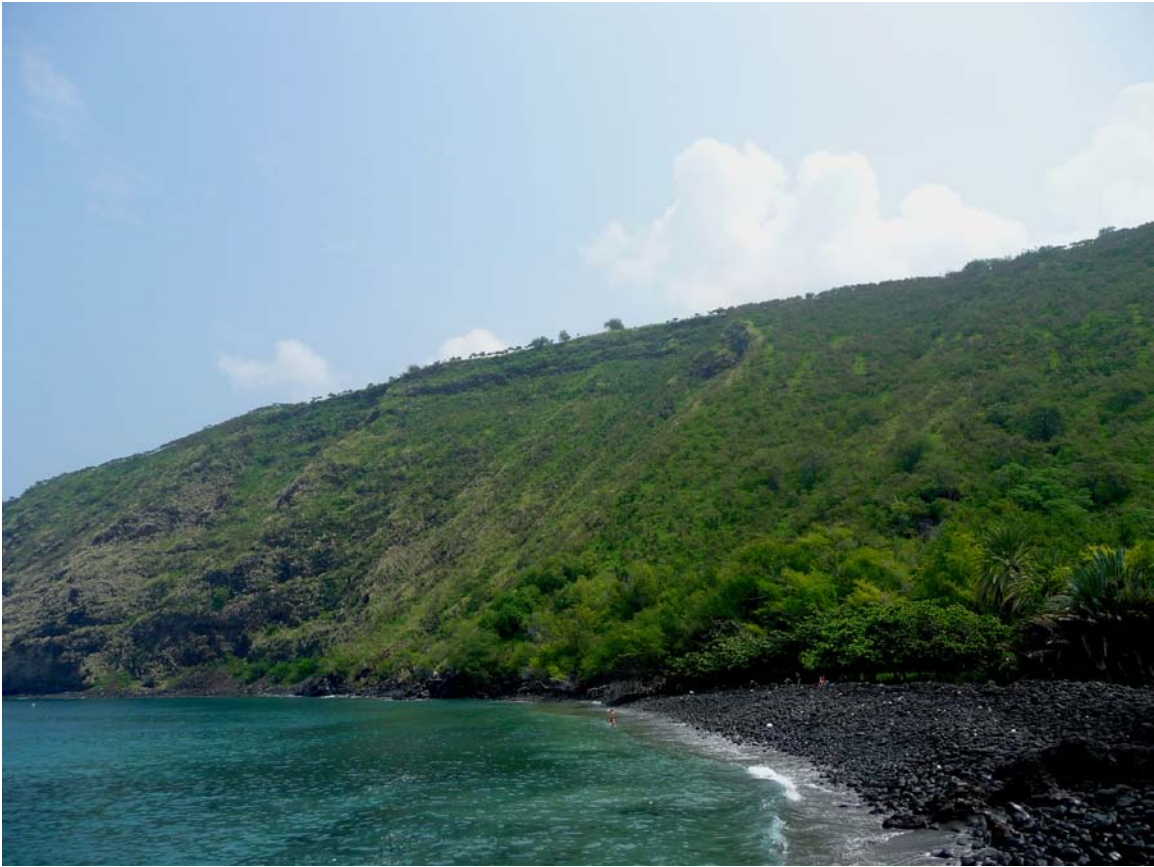
36.12. View of the sea cliff, showing recovery of vegetation near a heiau at Napo‘opo‘o (view to the north-northeast). USGS photo by N.A. Ikeda, 7/19/2008 (nai748).

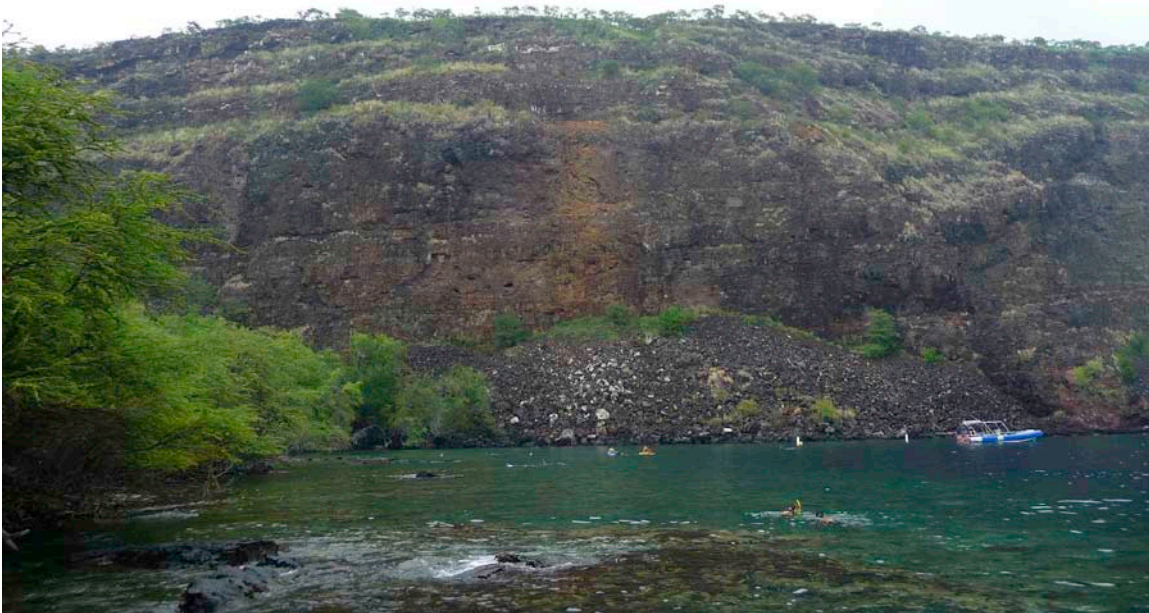
36.13. View of the sea cliff north-northeast of Captain Cook Monument, on the Kaʻawaloa lava delta, showing orange-brown discoloration of rock-fall path and slow recovery of vegetation on vertical cliffs, where soil deposit is lacking (view to the northeast). USGS photo by N.A. Ikeda, 7/19/2008 (nai764).
